NASA/TM-2007-215087

Validation Test Results for Orthogonal Probe Eddy Current Thruster Inspection System

Russell A. Wincheski
Langley Research Center, Hampton, Virginia

Recent nondestructive evaluation efforts within NASA have focused on an inspection system for the detection of intergranular cracking originating in the relief radius of Primary Reaction Control System (PRCS) Thrusters [1-3]. Of particular concern is deep cracking in this area which could lead to combustion leakage in the event of through wall cracking from the relief radius into an acoustic cavity of the combustion chamber. In order to reliably detect such defects while ensuring minimal false positives during inspection, the Orthogonal Probe Eddy Current (OPEC) system has been developed. The technique incorporates a dual frequency, orthogonally wound eddy current probe mounted on a stepper motor controlled scanning system. The system is designed to inspect for outer surface damage from the interior of the thruster. As the outer surface of the thruster is inaccessible without extensive disassembly, this enables on vehicle or routine depot level inspection of thrusters for relief radius intergranular cracking. A m

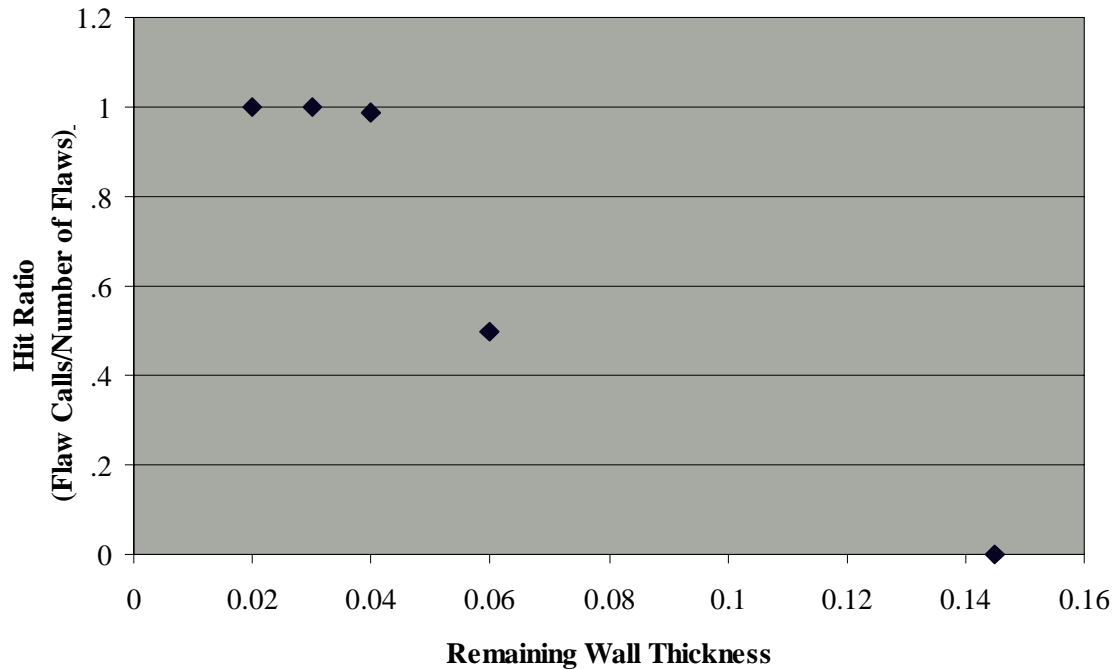
Flaw calls were reported by the inspectors immediately following the scan of a given cavity. This call data along with specific inspection criteria and all raw data were then recorded before the next cavity was inspected. Figure 1 displays a plot of the flaw call results. In this plot the hit ratio for flaws at each remaining wall thickness is calculated as the number of flaw calls divided by the number of opportunities to detect flaws of that remaining wall thickness. All unflawed cavities are plotted at a thickness of 0.145", the approximate minimum wall thickness between the relief radius and acoustic cavity in the absence of any flaws. All inspections at sites with 0.020" and 0.030" remaining wall thicknesses were called along with 89/90 0.040" remaining wall thickness sites and 18/36 0.060" flaw sites. No false positives were reported from any of the unflawed cavities.

Figure 1. Hit ratio for flaws at all 1512 cavities inspected during validation testing.

A closer look at the data reveals additional information concerning the undetected flaws. Strong evidence exists that the one missed call at 0.040" remaining wall thickness is due to a missed inspection site rather than a missed call at the site with 0.040" remaining wall thickness. It appears a duplicate inspection was performed on the cavity prior to the cavity in question (S/N 713, AC16) which was then skipped over on the next inspection. All other inspections of S/N 713 AC 16 produced strong flaw response. The remaining missed calls all occurred at the sites corresponding to the 0.060" remaining wall thickness flaw originating between adjacent acoustic cavities (S/N451 AC5-AC6). The two flaws with 0.060" remaining wall thickness which originate directly across from the acoustic cavity (S/N 713, AC32 and S/N 714 AC37) were detected in every inspection cycle.

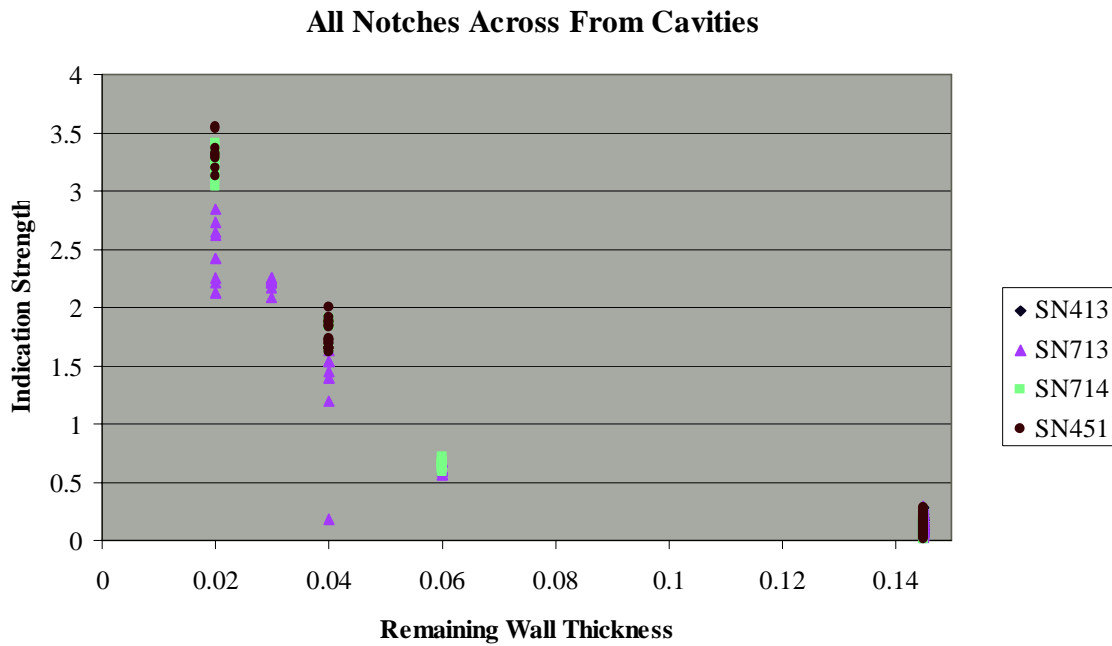
Another method for examining the validation test results is to plot the system response versus remaining wall thickness. The data fall into two main clusters depending upon the orientation of the flaws. Figure 2 displays the results for all flaws originating across from an acoustic cavity. The plot contains the results from all nine inspection cycles. The indication level for all unflawed cavities is shown as the cluster of points at 0.145" remaining wall thickness. The single missed inspection at S/N713 acoustic cavity 16 (0.040" remaining wall thickness) is clearly out of family with the remainder of the data and, as discussed above, is the result of a missed inspection of that site. Otherwise the data show a strong correlation between indication strength and remaining wall thickness with a clear distinction between all flawed and unflawed cavities. An indication strength of 0.5 volts was set by procedure to be the threshold for a relevant flaw indication [3].

were introduced at angles of 30, 45 and 60 degrees. While the 30 and 45 degree flaws showed a similar response to the inspection system, edge effects associated with the proximity of the 60 degree flaw tip to the thruster face resulted in slightly reduced detection sensitivity. It should be noted that such high angle flaws appear to be rare. Destructive analysis performed by the NASA Engineering and Safety Center on PRCS Thruster S/N 132 found flaw angles to be typically between 40 and 50 degrees with a maximum measured flaw angle of 54 degrees [6].

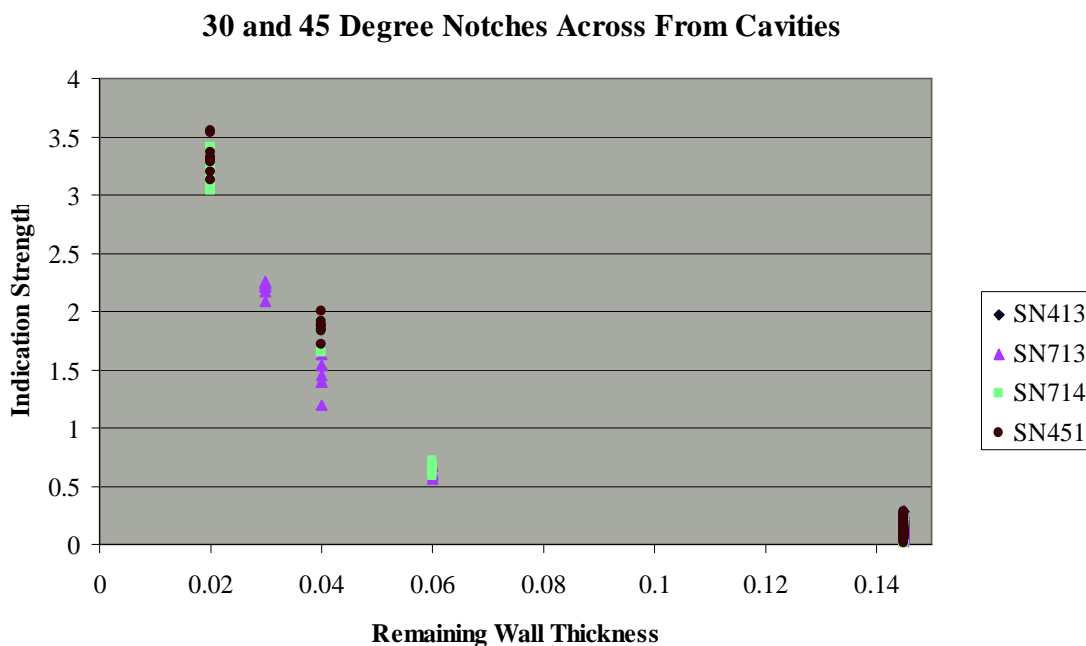
In figures 4 the 60 degree flaws have been removed to show the strong correlation between remaining wall thickness and indication strength for the 30 and 45 degree flaws originating across from an acoustic cavity. The missed inspection at S/N 713 AC 16 has also been removed for clarity. Figure 5 shows the equivalent data for flaws originating between adjacent acoustic cavities. Here the plotted indication strength is the average of the recorded signal from the acoustic cavities on either side of the flaw. Averaging these values helps to correct for potential misplacement of the flaw between the cavities.

Figure 4. Indication strength for 30 and 45 degree notches originating across from an acoustic cavity.

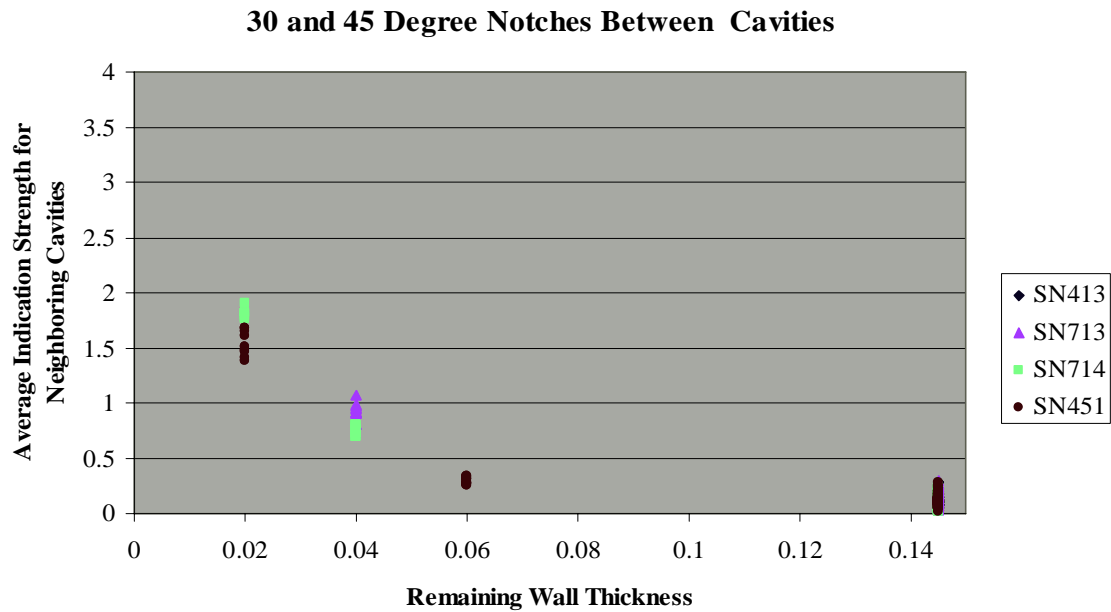
Figure 5. Inspection Results for 30 and 45 degree notches originating between adjacent acoustic cavities. Indication strength calculated from average of cavities on either side of notch.

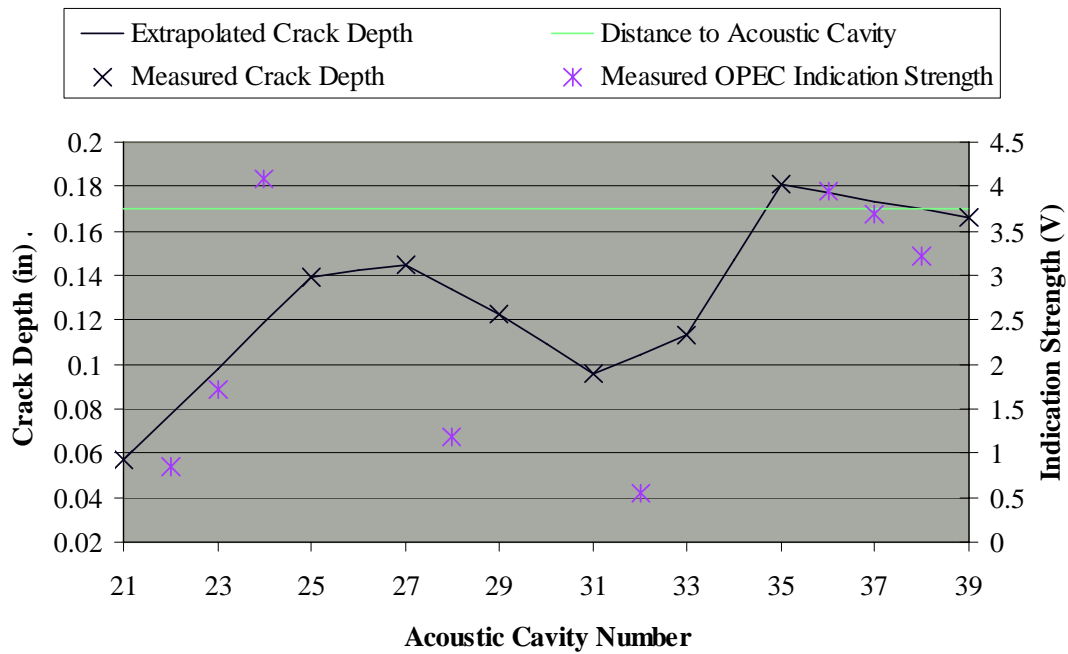
In this work the eight remaining inspection sites on PRCS Thruster S/N 132 were examined with the OPEC system. As describe in the NESC Report [6], sections of this thruster have been destructively examined and crack depths measured. Figure 6 displays the indication levels from this naturally occurring damage along with measured crack depths. The data acquired from acoustic cavities 37 and 38 each showed saturation in the low frequency (12 kHz) response along with a very strong vertical response in the high frequency (100 kHz) data. As the standard depth of penetration of the electromagnetic field in the thruster is approximately 0.070” at 12 kHz but only approximately 0.025” at 100 kHz, this indicates that the discontinuity in the material extends very close to the acoustic cavity wall and is potentially a through wall flaw in these locations.

Figure 6. Inspection results for intergranular cracking in PRCS thruster S/N 132. Plot contains OPEC inspection results along with destructive analysis of thruster.

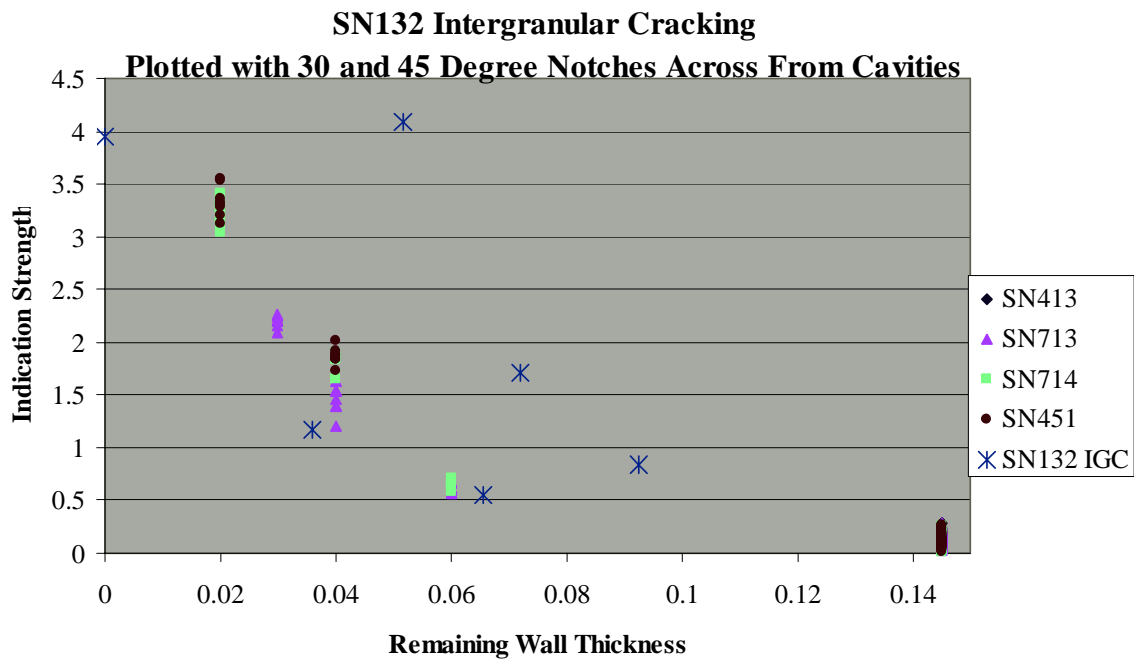
By extrapolating the measured crack depths from the destructive analysis of S/N 132 through an area with a preseved acoustic cavity an approximation of the remaining wall thickness at the OPEC inspeciton site can be determined. Figure 7 plots the extrapolated remaing wall thickness in thruster S/N 132 versus indication strength for the OPEC system inspections. The responses from acoustic cavities 37 and 38 have been removed from the plot due to system saturation at these inspection sites. Figure 7 also contains the data for the 30 and 45 degree notches placed across from an acoustic cavity. The data show that the signal level from naturally occurring damage is comparable to, or even higher, than that for the validation notches. A likely cause for the increased signal levels on naturally occurring damage is the flaw profile. All naturally occurring damage identified to date has shown a very high aspect ratio of crack length to crack depth. The notch standards were all fabricated with a two to one aspect ratio, and therefore likely underestimate the crack length at a given remaining wall thickness. The likely flaw aspect ratio also minimizes the potential for deep cracking between acoustic cavities without appreciable damage directly in front of a single cavity.

Figure 7. Plot of indication strength versus interpolated remaining wall thickness for naturally occurring intergranular cracking in comparison to 30 and 45 degree notches placed across from an acoustic cavity.
